URGENT SAFETY NOTICE, CAPTUS 4000E THYROID UPTAKE SYTEM

Captus 4000e Serial Numbers 940001 through 940547

Date Range: August 2015 through April 2019

Revised April 1, 2024- adding risk of retention plate failure

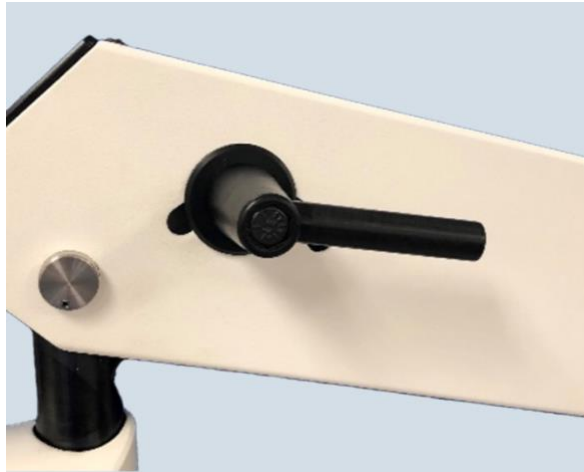
Figure 1: Spring Arm Locking Handle

- d. Once in position, secure the arm by tightening the locking handle prior to performing Thyroid Uptake and Bioassay Procedures, as shown in figure 1.
- e. Perform Thyroid Uptake and Bioassay Procedures with patient (or employee, for Bioassay Procedures) in a **seated position**, rather than a supine position on a table.
- f. Store the arm in an upright position. This places the least amount of stress on the internal components. Engage the locking handle when the spring arm is not being raised or lowered. Avoid putting the spring arm in its lowest position as much as possible. This position puts the most stress on the internal components.

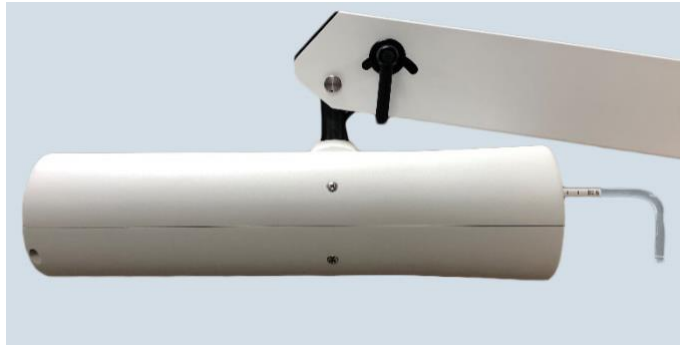
Figure 2: Collimator Positioning

1. Turn the Collimator to the horizontal position as indicated in figure 1.

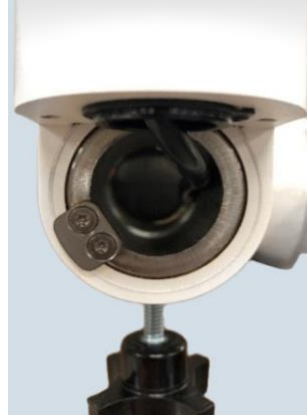
Figure 7: Front View

3.2. Visually inspect the two screws, identified in figure 4. The internal steel insert, brass liner and outer protective plastic cover should all be even, retention plate should be level, straight, and flush against the collimator, and the screws should level and flush with the retention plate. Figures 6, 7 and 8 show a properly assembled collimator.

If this inspection shows that the collimator is properly attached as shown in figures 6, 7, and 8 then your Captus 4000e System can continue to be operated. However, please be cautious when moving the collimator. Please refrain from quickly spinning the collimator or using strong pulling forces on it. The plate is still at risk from failing if the collimator is used too aggressively.

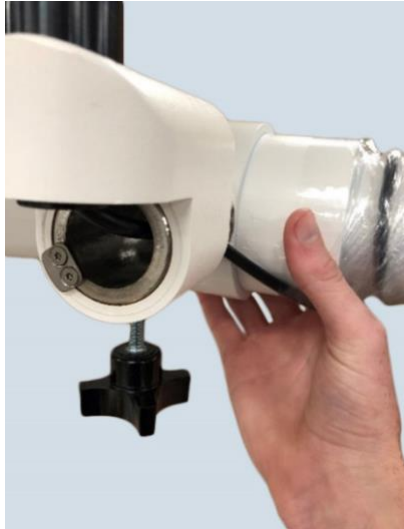
Figure 11: Hand Support Positioning

4. Next, check whether or not the retention plate is loose and can move. With one hand grab the Collimator as indicated in figure 11 and with the other hand gently attempt to move the Pin Retention Plate in the modes indicated in figures 12 and 13 below.

- 4.1. If you do not believe that you can fully support the collimator with one hand, get someone to help you. The retention plate on a properly attached collimator should feel snug and should not move when pushed gently with one finger. Do not try to forcibly move the plate or use a tool to try and move it. **Note: If the plate is loose and moves with gentle pressure immediately take the unit out of service and contact Capintec Technical Support.**

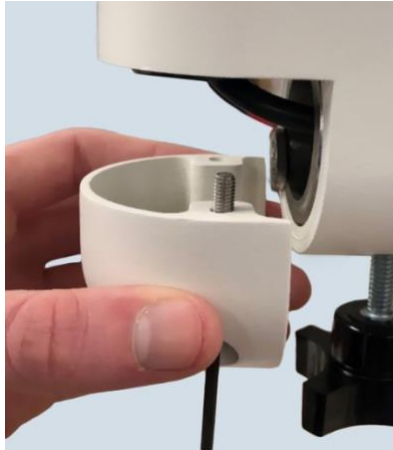
Figure 14: Housing Re-Assembly

6. Once the inspection has been completed, the back housing can be reattached to the collimator block assembly. Insert the first screw into the back housing as shown in figure 14, then move the housing to the collimator block assembly. Initially turn the screw counterclockwise until it is properly seated, then turn the Allen Wrench clockwise to tighten the screw. Insert the second screw into the housing assembly and fully tighten.
