April 1, 2024

URGENT SAFETY NOTICE, CAPTUS 4000E THYROID UPTAKE SYSTEM

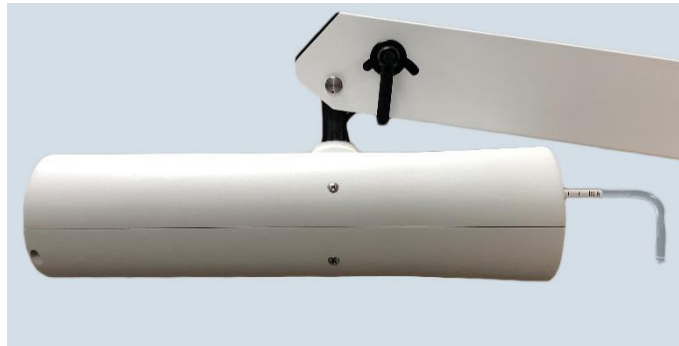
Figure 2: Collimator Positioning

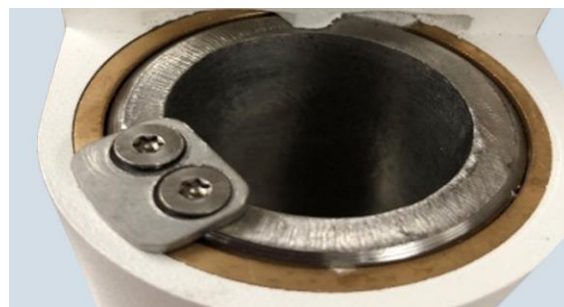
Figure 10: Example 2

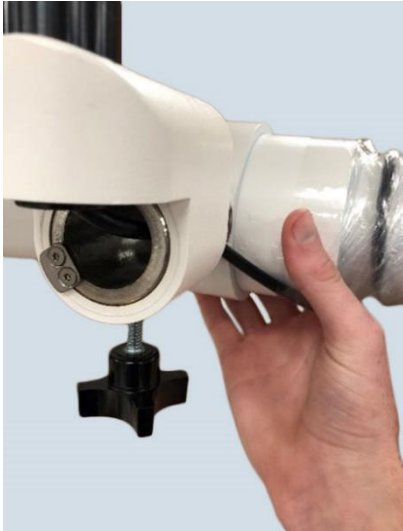
Figure 11: Hand Support Positioning

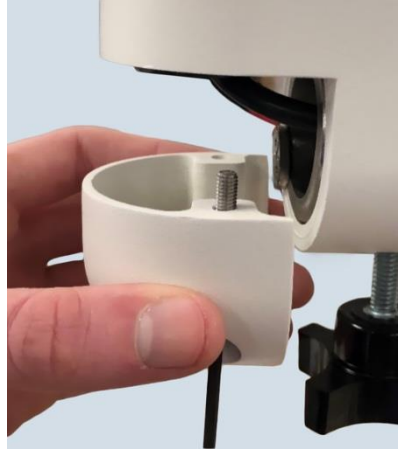
Figure 14: Housing Re-Assembly
